# APPENDIX A

## NATURAL RESOURCES

## Natural Areas Management Guidelines Pease Park Master Plan

## LANDSCAPE MANAGEMENT PHOTOPOINTS

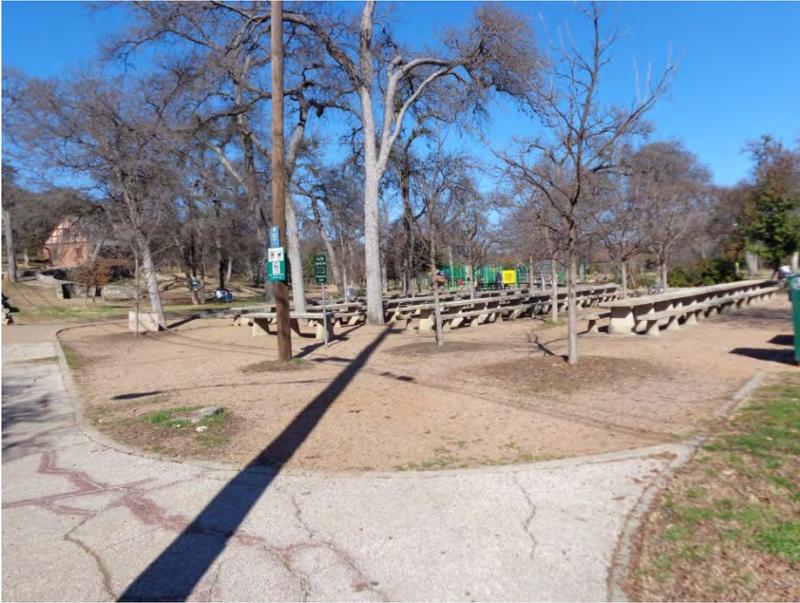
**Photopoint: 1**      **Direction: N**

Main picnic area at Kingsbury Commons with concrete Works Projects Administration era benches. Large cedar elms have severe mistletoe infestations and will require extensive pruning. Young trees, principally burr oak and cedar elm have been interplanted in the older cedar elm

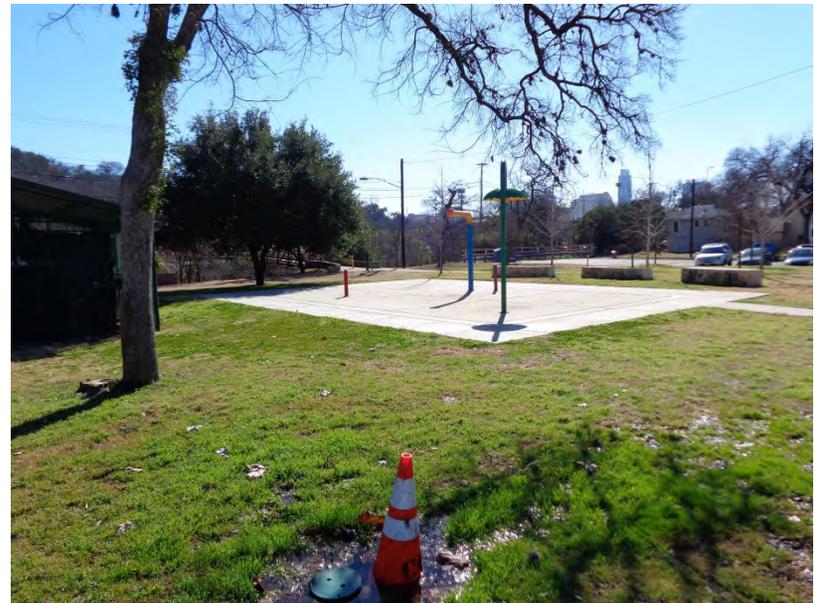
**Photopoint: 1**      **Direction: N**

A diverse assemblage of trees have been planted throughout Kingsbury Commons and the big field since 2000. Species planted include burr oak, honey locust, Monterrey oak, chinquapin oak, sycamore, cedar elm, live oak, and shumard oak.

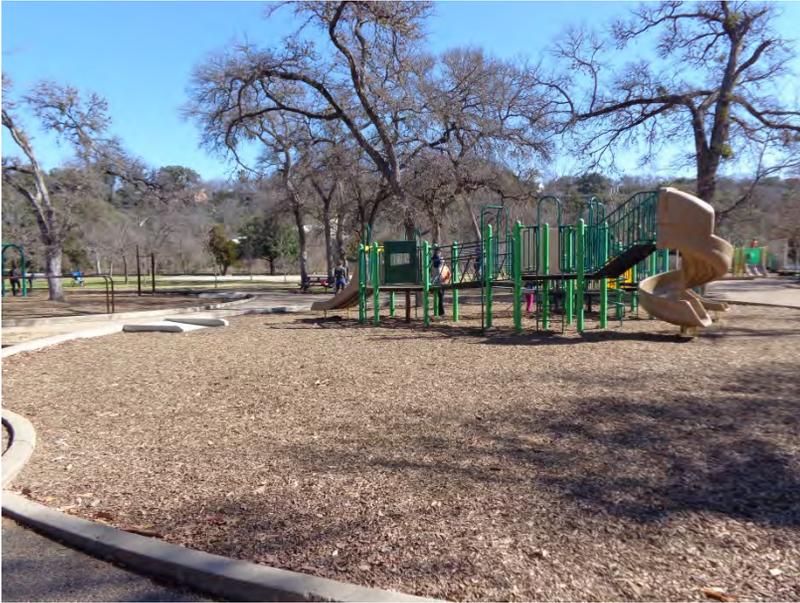
**Photopoint: 4**      **Direction: E**  
Playground with large, mistletoe infested, cedar elm.

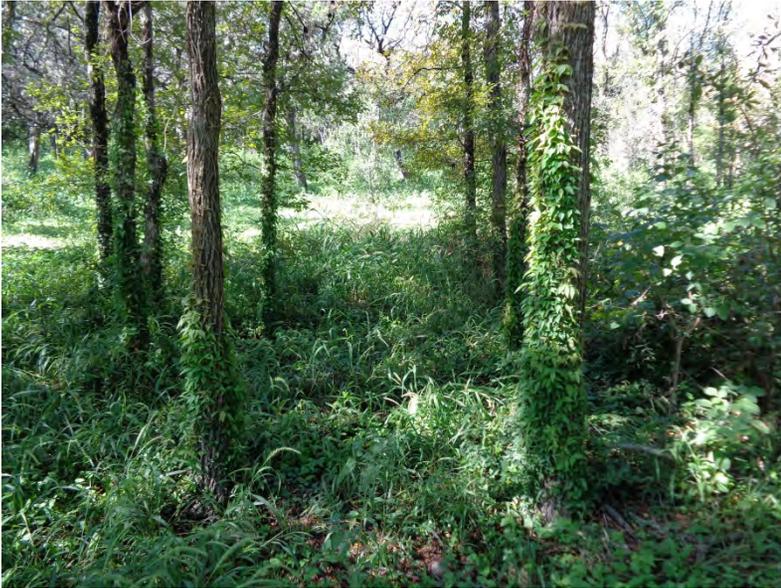
**Photopoint: 6**      **Direction: N**  
Small infestation of the non-native invasive catclaw vine.

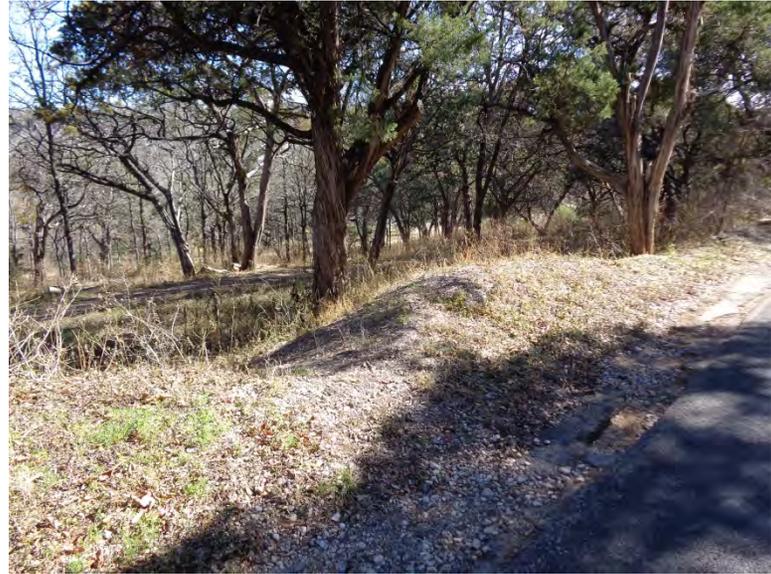
**Photopoint: 8**      **Direction: E**  
An earthen berm is found along the south side of Kingsbury Street.

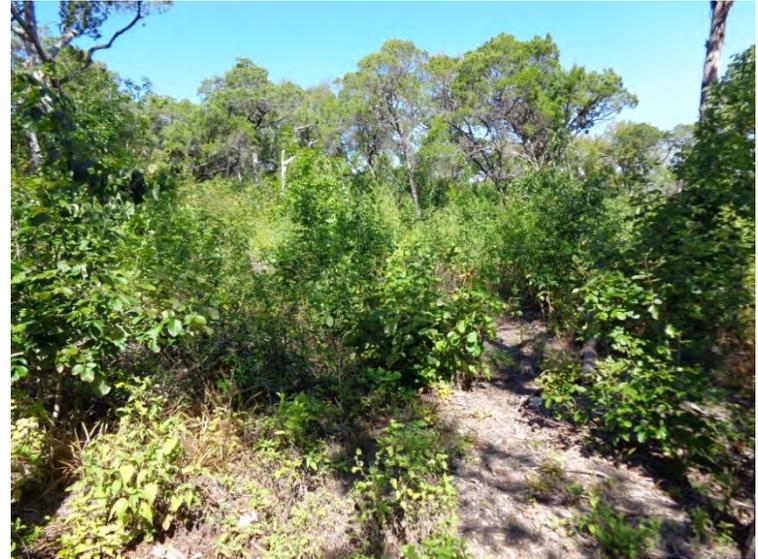
**Photopoint: 9**      **Direction: W**

Representative photo of Windors Hillside slope forest. This portion of the forest is heavily infested with Chinaberry and other woody invasive species.

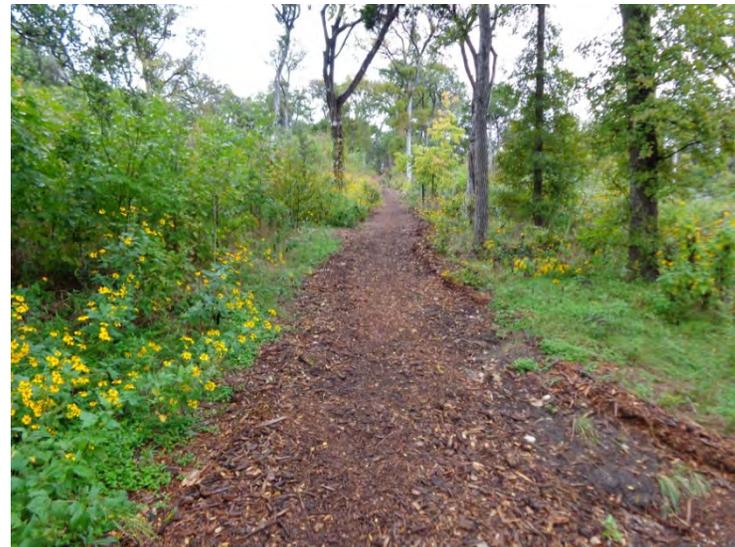
**Photopoint: 12**      **Direction: NW**

Representative picture of mulched trails found in the Hillside and North Ramble areas. These trails do not contain waterbars or other ways for water to exit the trail, which is already leading to minor erosion problems that will likely become worse unless trails are improved.

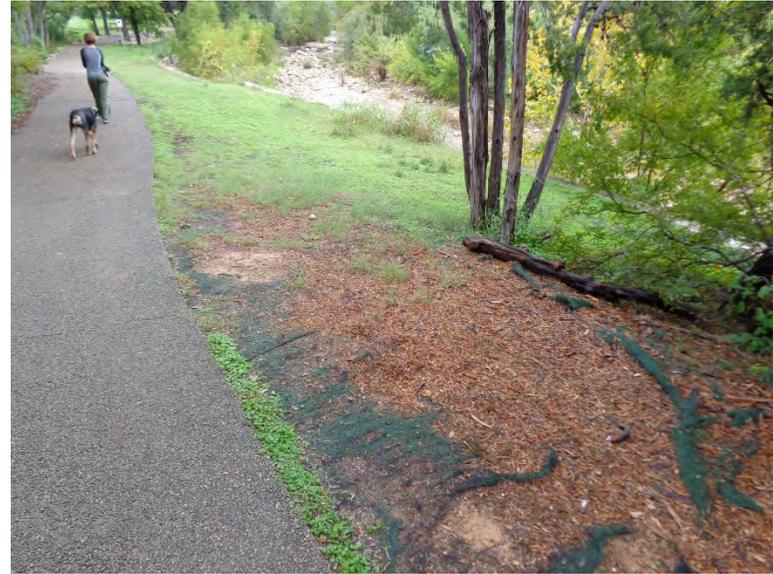
**Photopoint: 14**      **Direction: NW**

Section of trail with large amount of exposed erosion control blankets that are beginning to degrade and fold.

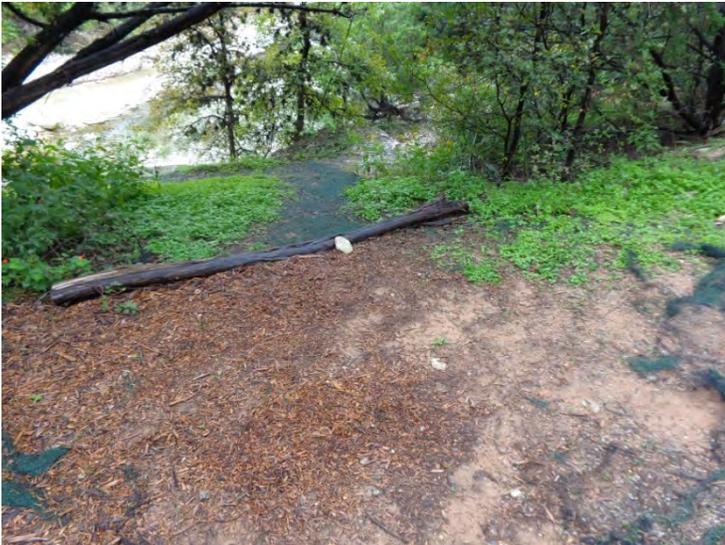
**Photopoint: 14**      **Direction: NE**

Although a cedar log has been placed here to reduce the speed of water, runoff and foot traffic have exposed erosion control blanket and prevented the area from revegetating.

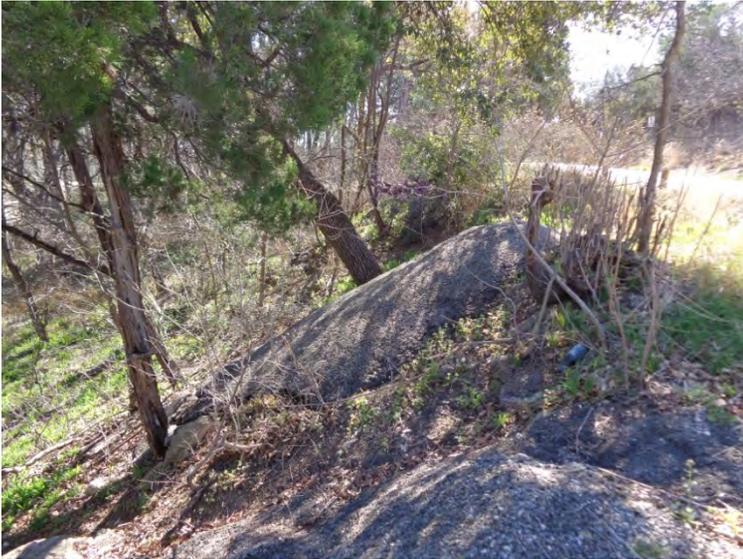
**Photopoint: 15**      **Direction: SW**

Rock re-enforced slope in area with erosion concerns.

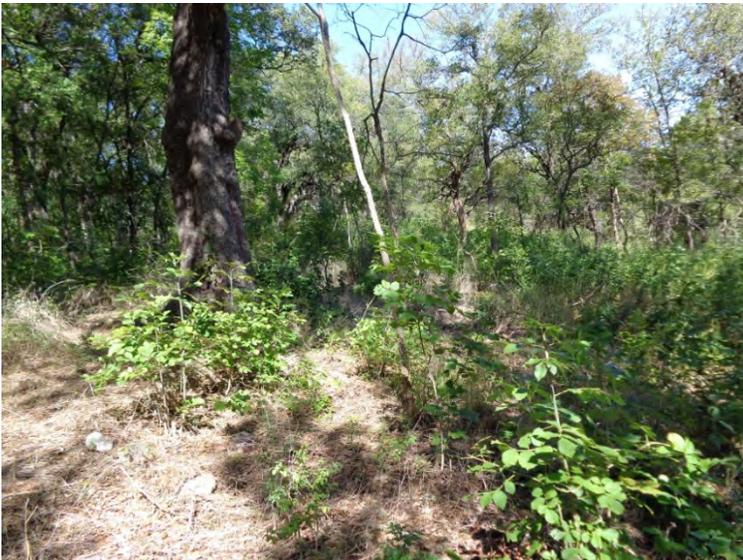
**Photopoint: 18 Direction: E**

Invasive species are prevalent in Windsor Hillside character area. Here, catclaw vine, Japanese privet and Chinese parasol tree dominate, although Mexican buckeye is also present.

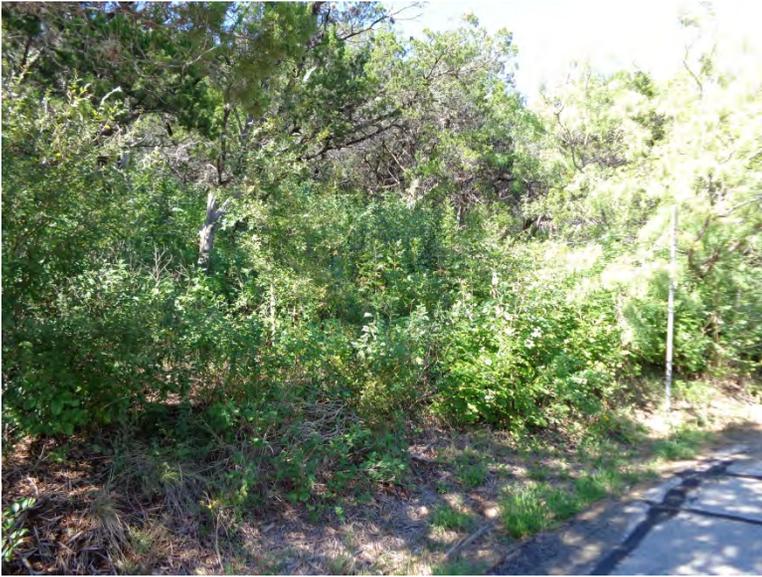
**Photopoint: 19 Direction: W**

Invasive exotic catclaw vine overtopping trees, smothering the herbaceous layer, and forming a monoculture.

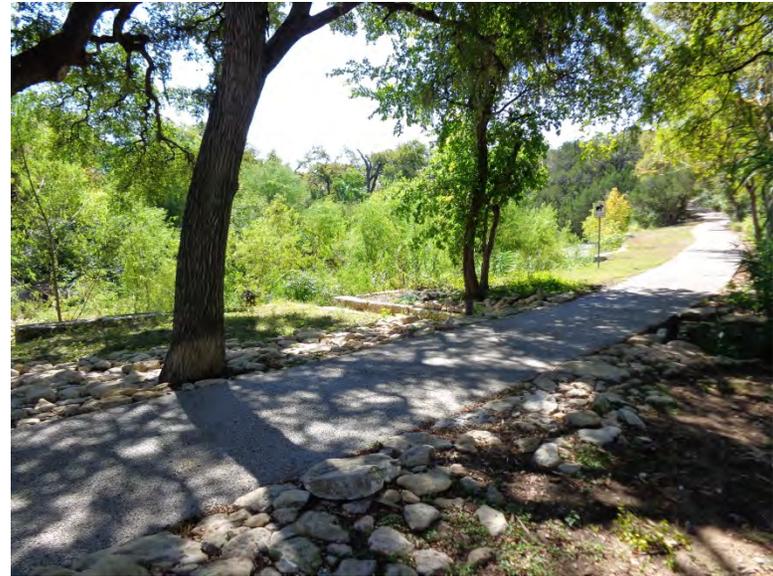
**Photopoint: 21**      **Direction: SE**  
Ground near main trail has been lined with rock in this area.

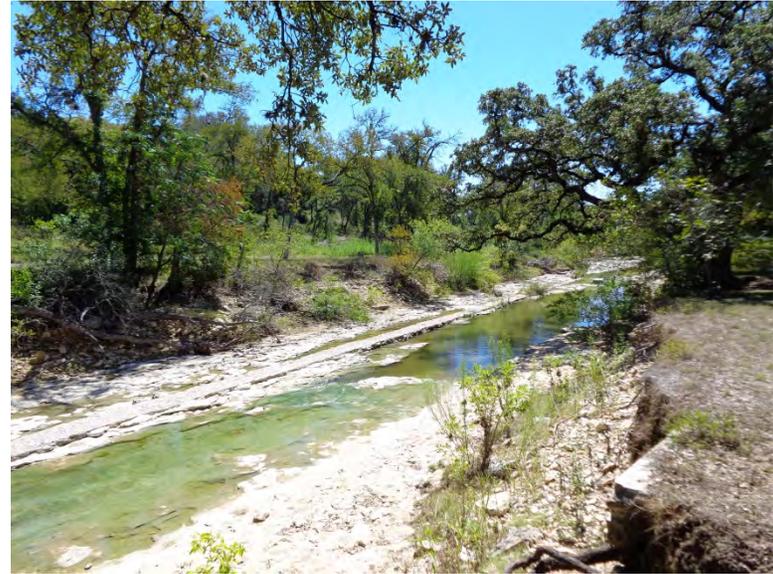
**Photopoint: 23**      **Direction: N**

Low rock berm installed to reduce sheet erosion through the center of Custer's meadow.

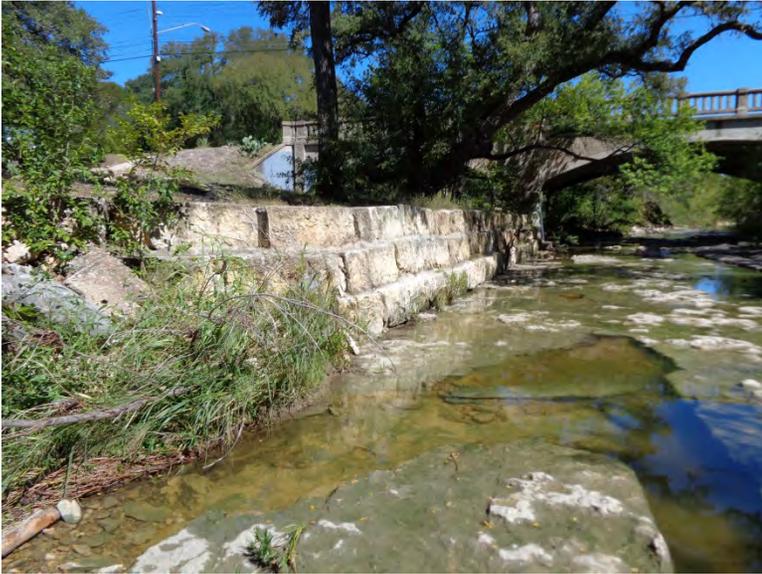
**Photopoint: 26**      **Direction: NNE**

Representative picture of armored wall that is found along some sections of Shoal Creek.

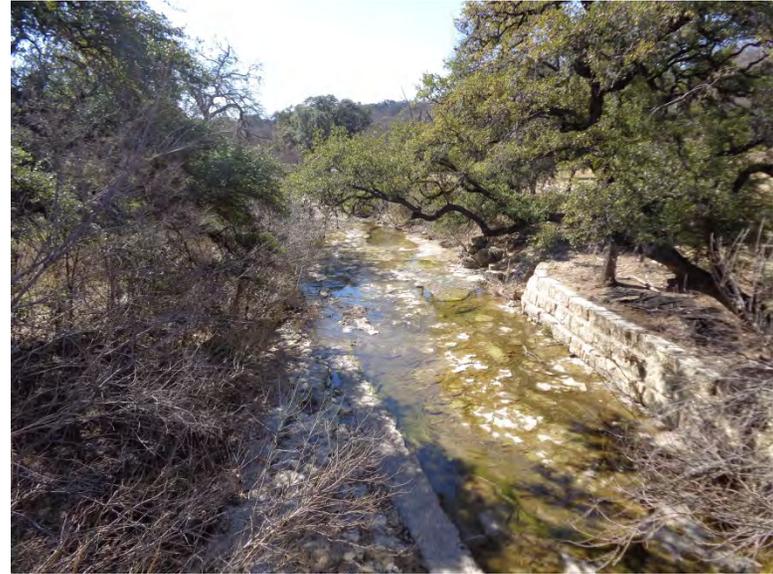
**Photopoint: 28**      **Direction: S**

View of creek from the 24<sup>th</sup> Street bridge. Many stately live oaks are found in this section of the creek, although erosion is exposing the roots of the live oaks in the right side of this picture.

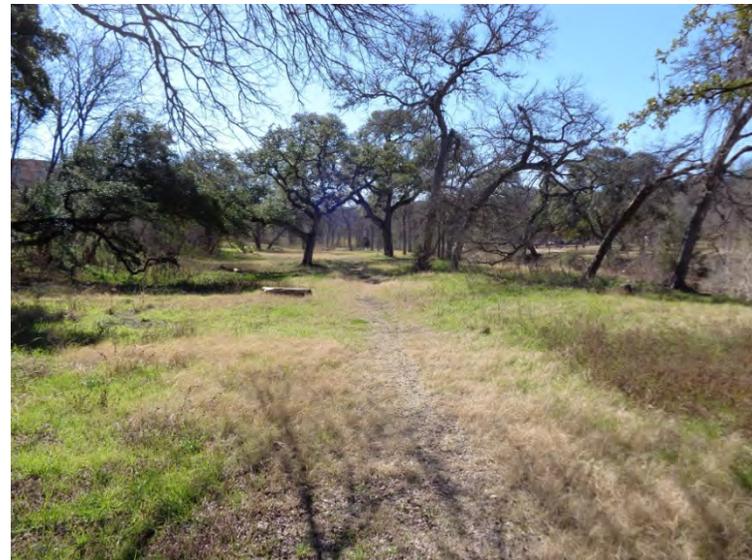
**Photopoint: 27**      **Direction: NNE**

Informal access point on the southwest side of the 24<sup>th</sup> Street bridge has led to erosion and destruction of the herbaceous layer.

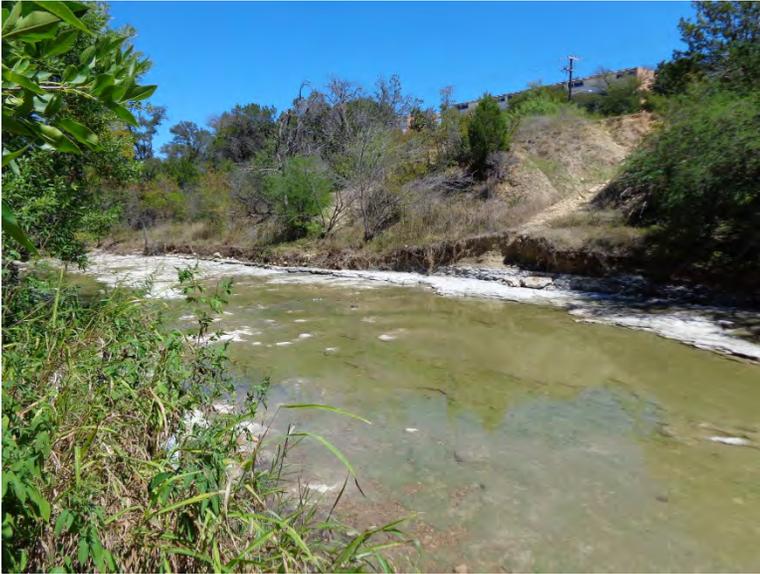
**Photopoint: 32**      **Direction: SE**  
Exposed soil on the east bank of Shoal Creek. This area will be resculpted and replanted by the City of Austin Watershed Protection Department.

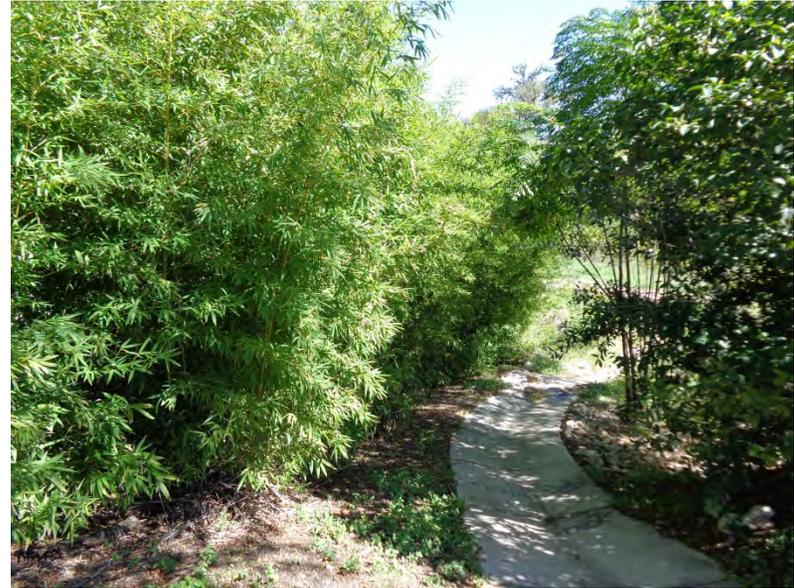
**Photopoint: 39**      **Direction: N**  
Storm water drainage with a wall of bamboo on the left and dense stand of Japanese privet on the right.

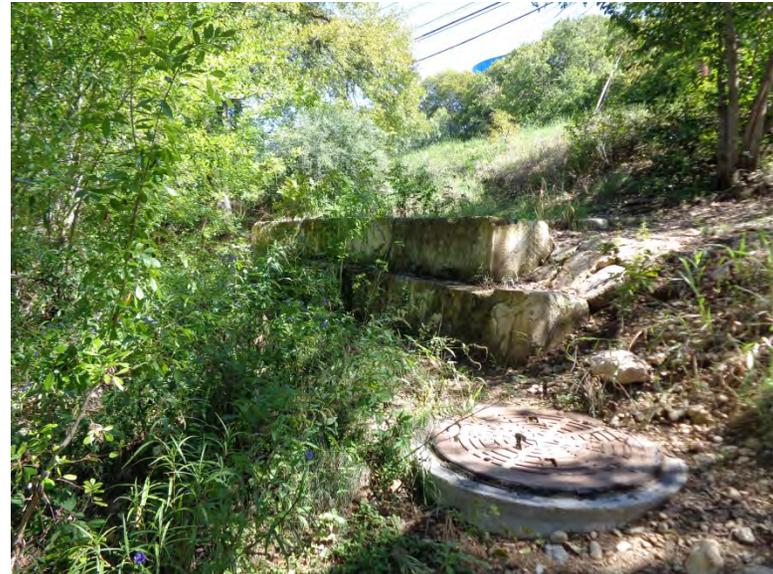
**Photopoint: 40**      **Direction: N**  
Manhole cover, armored wall and both Japanese and Chinese privet are found at this location.

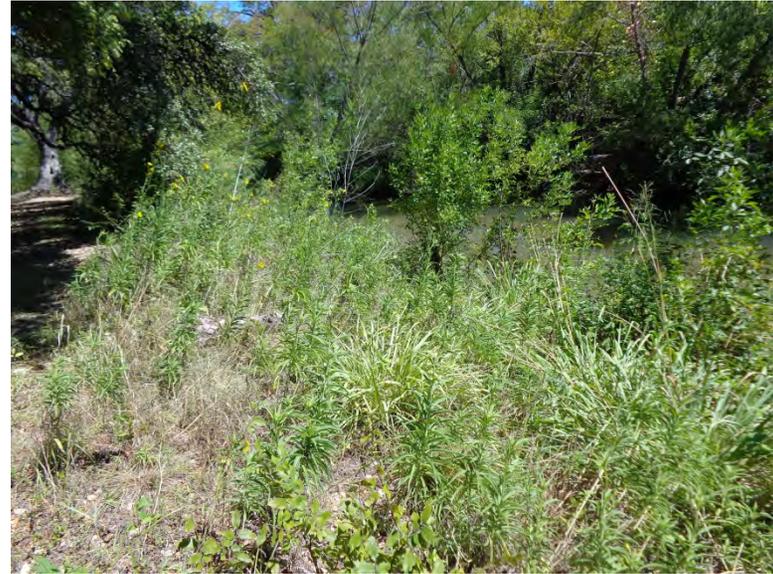
**Photopoint: 41**      **Direction: N**

Cedar elm grove in Wooten Woods, has had mulch placed over the tree roots, but continues to receive heavy foot traffic, even with the rocks demarking the trail edge.

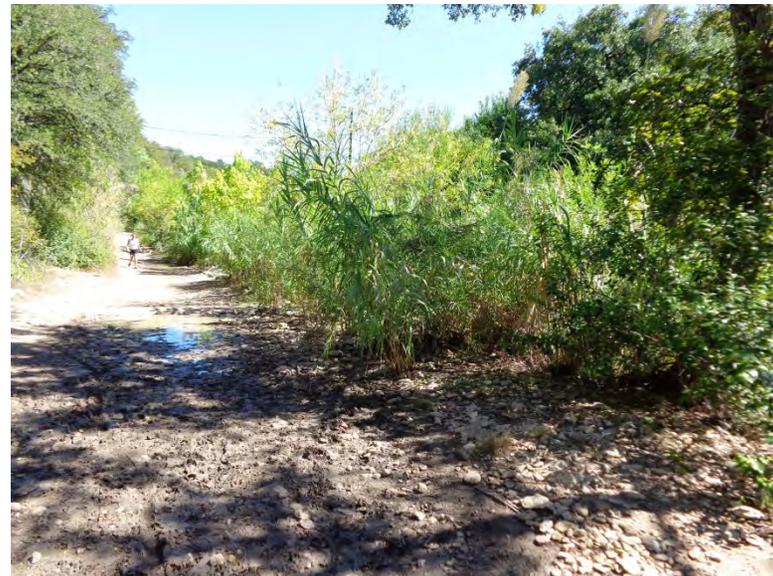
**Photopoint: 42**      **Direction: S**

Unstructured high use has denuded the banks of Shoal Creek at this location. The invasive Mexican petunia is one of the few herbaceous plants left here.

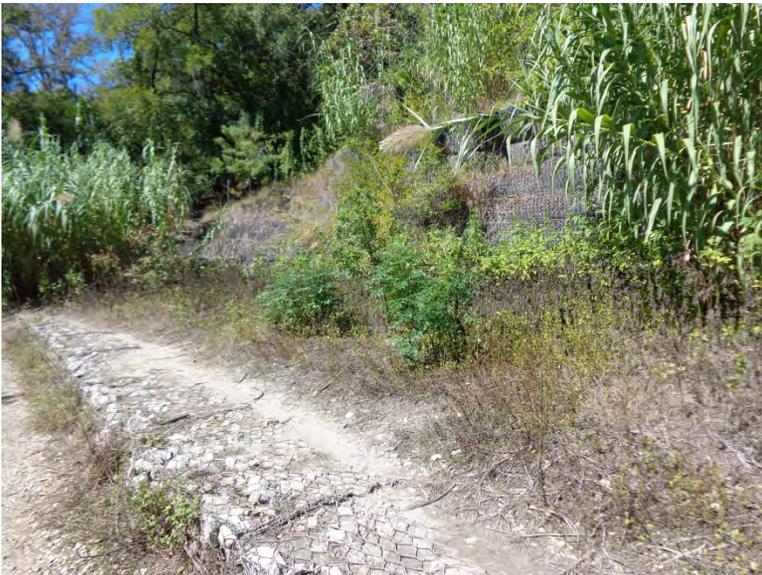
**Photopoint: 46**      **Direction: W**

Gabian wall where a seep contributed to slope failure in the past. The slope is now dominated by Giant Cane.

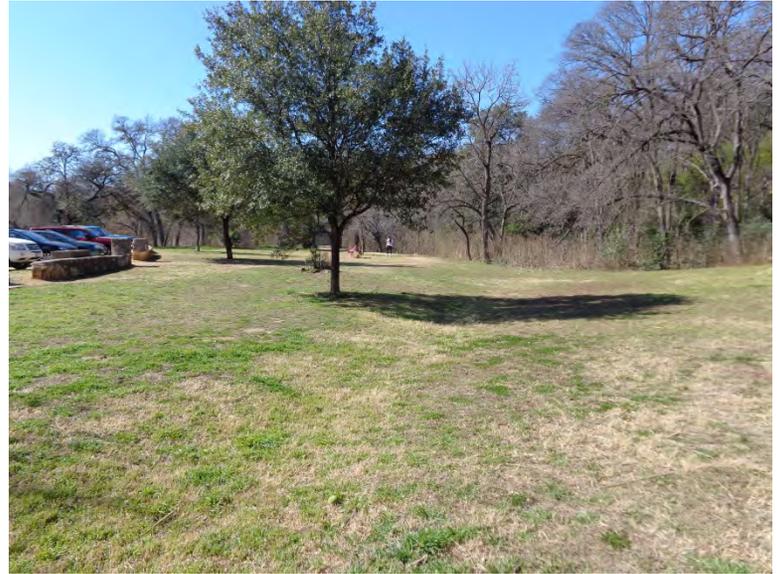
**Photopoint: 48 Direction: S**  
Seepage entering park.

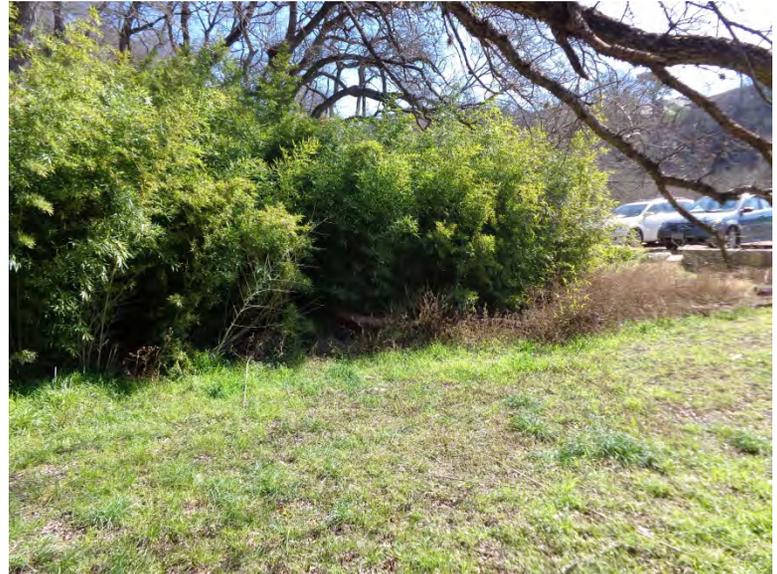
**Photopoint: 49 Direction: E**  
Bamboo infestation at the northeast edge of Gaston Green.

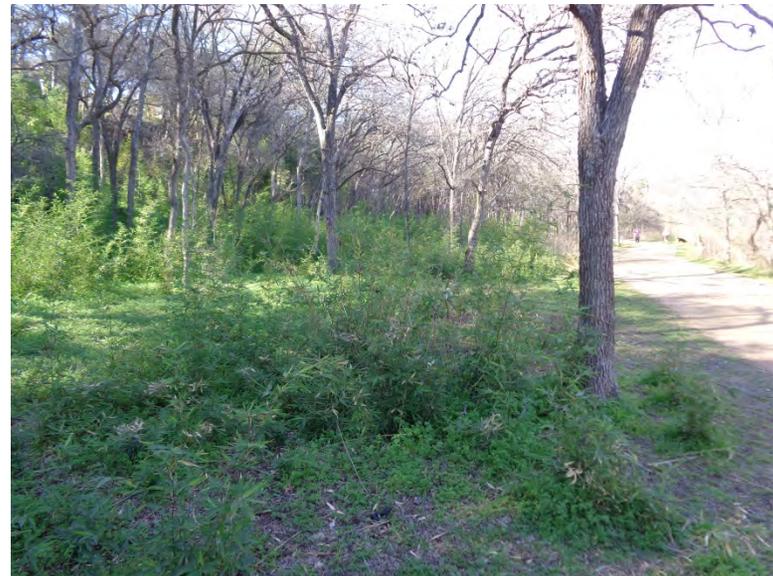
**Photopoint: 56**      **Direction: N**  
Bamboo dominates the understory to the west of the main trail for approximately 330 linear feet along the trail. It appears that the bamboo is cut occasionally, but this strategy is unlikely to result in any longterm control.

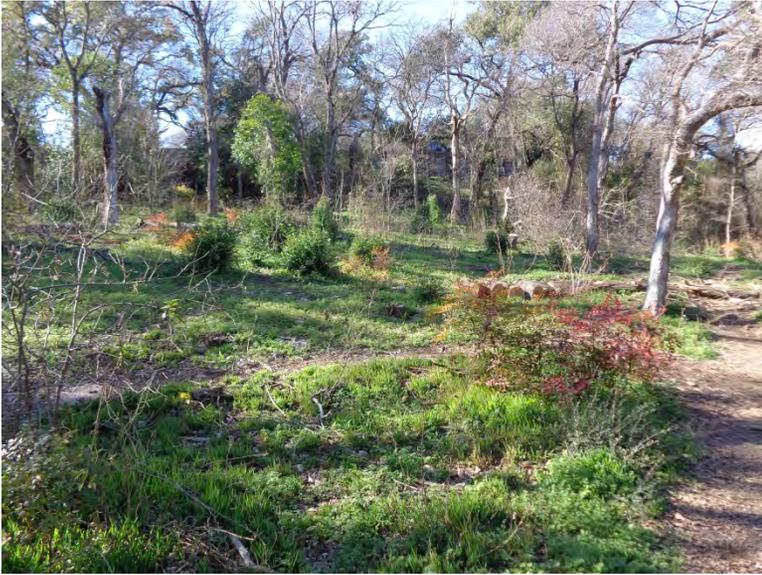
**Photopoint: 57**      **Direction: NW**

Area where many dead trees have been removed over the past few years. Reforestation will need to be carefully managed as many Chinaberry and privet saplings are becoming established, and heavenly bamboo is proliferating.

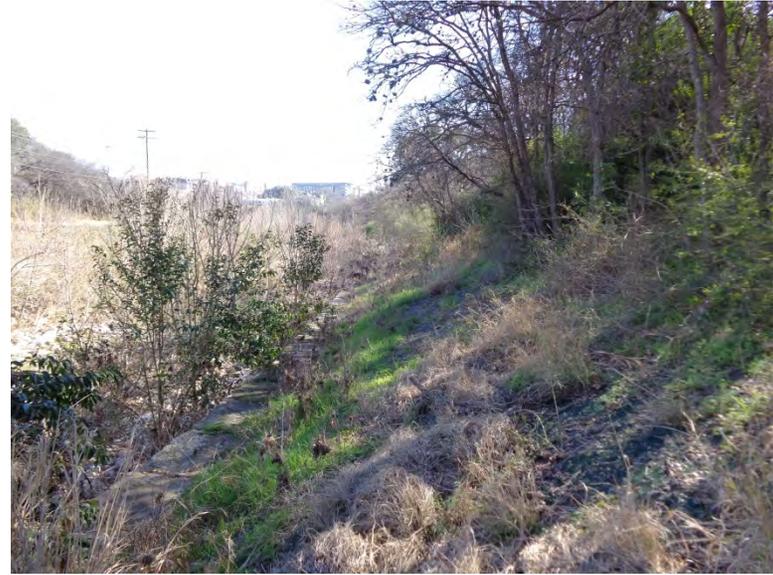
**Photopoint: 58**      **Direction: S**

Area between armored bank and tree line was covered with a green fiber mulch blanket, which is still exposed in many areas. Some small trees are just now becoming established amidst the green sprangletop and other mid level grasses.

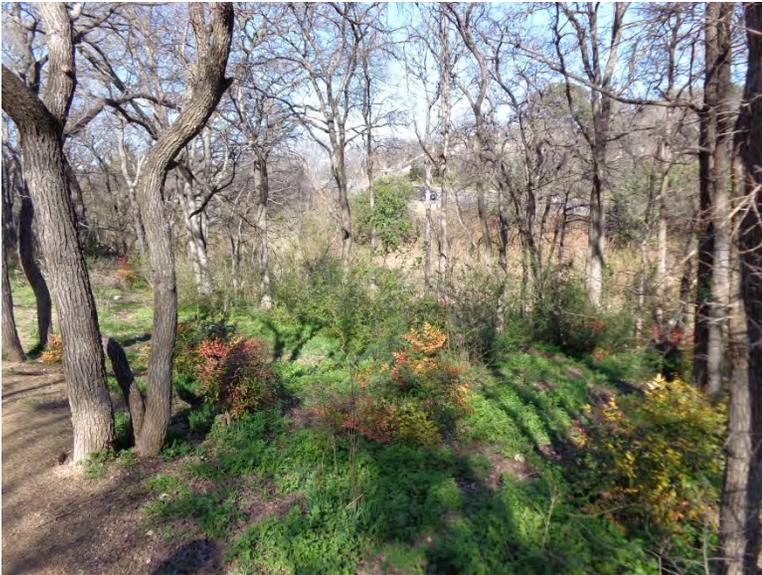
**Photopoint: 57**      **Direction: NE**

Understory appears to have been cleared a few years ago, and is now primarily young non-native invasive plants.

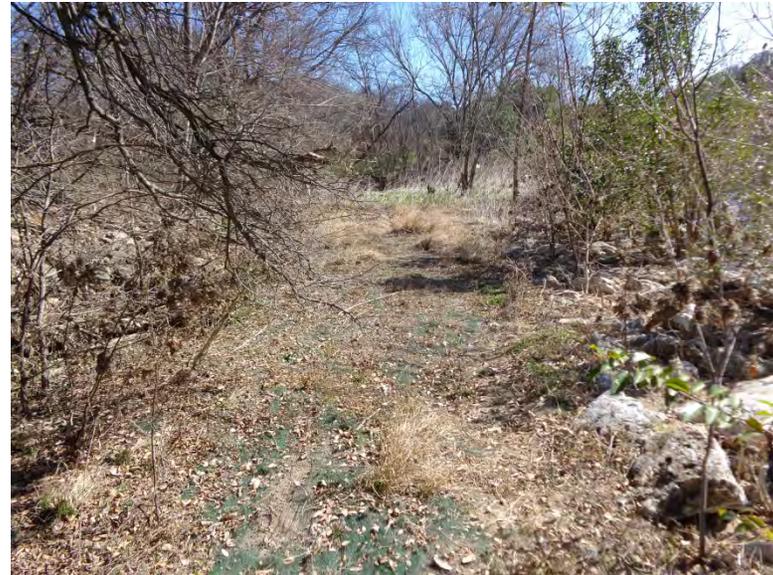
**Photopoint: 59**      **Direction: SE**

Very little tree recruitment is taking place where the fiber blanket was placed, although hackberry and gum bumelia are dense on either side of it.

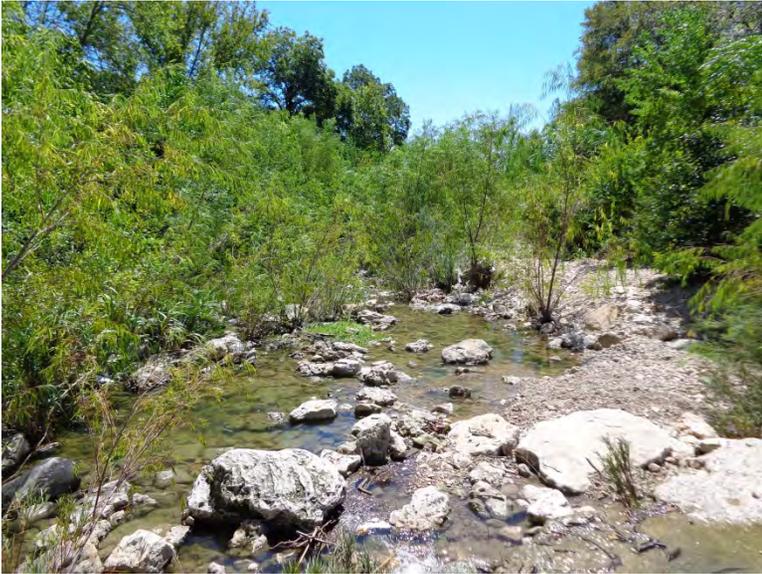
**Photopoint: 59**      **Direction: S**

Shoal Creek at the Janet Fish bridge. Banks are dominated by black willow, but Chinese tallow, chinaberry, Japanese privet, giant ragweed, boxelder, and green ash are also present.

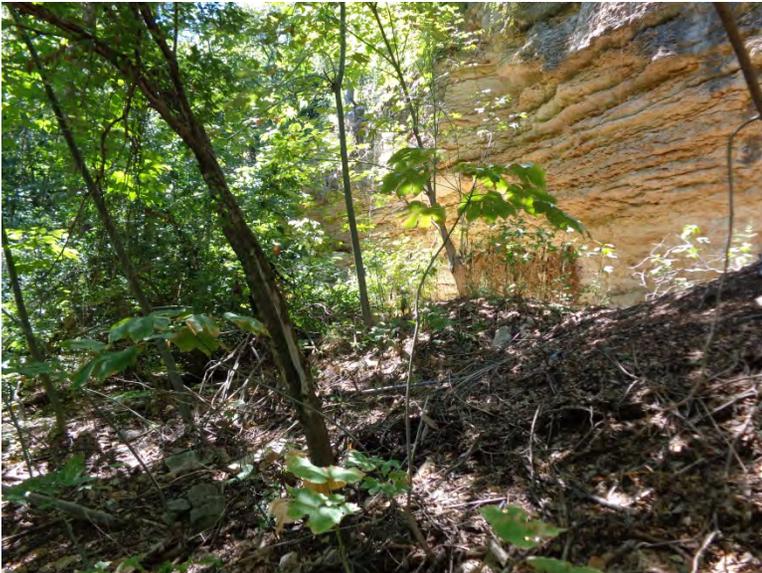
**Photopoint: 60**      **Direction: S**

Cliff face with Chinese parasol tree infestation at its base. Homeless encampments are frequently found under cliff overhangs in the project area.

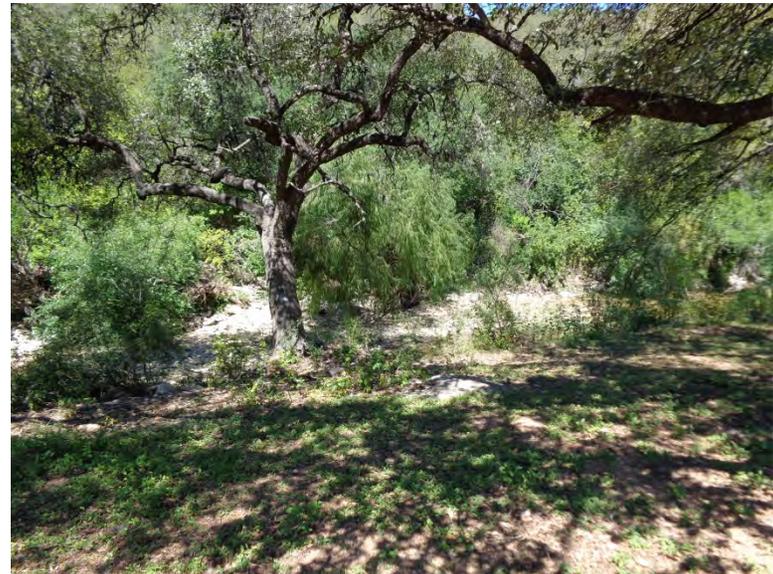
**Photopoint: 61**      **Direction: W**

Shoal Creek with live oak, black willow, and cottonwood.

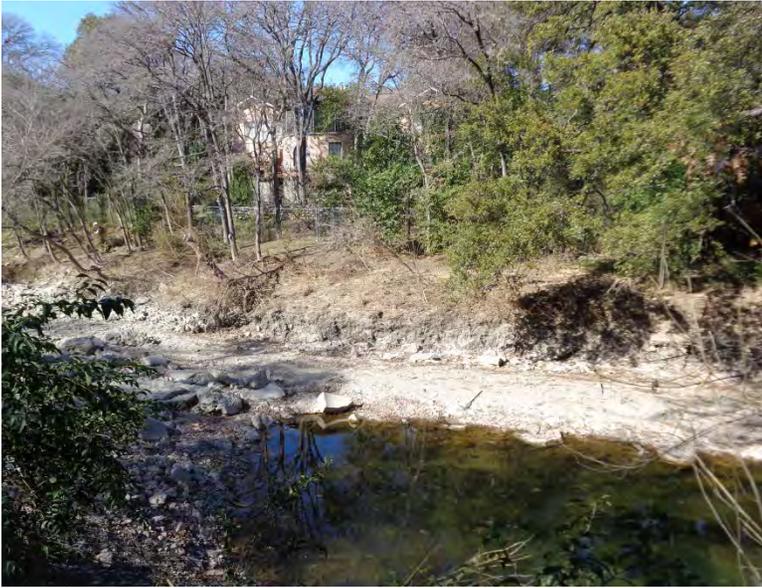
**Photopoint: 65**      **Direction: NW**

Bank erosion north of 29<sup>th</sup> Street is not uncommon, this section of the creek has not been armored.

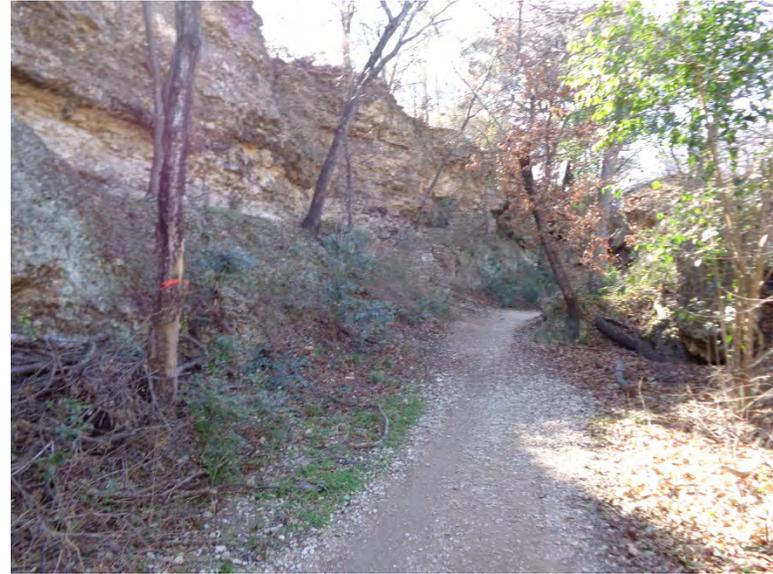
**Photopoint: 66**      **Direction: W**

Area of north of 29<sup>th</sup> Street is heavily infested with privet and Japanese honeysuckle, but also contains Mexican buckeye and cherry laurel.

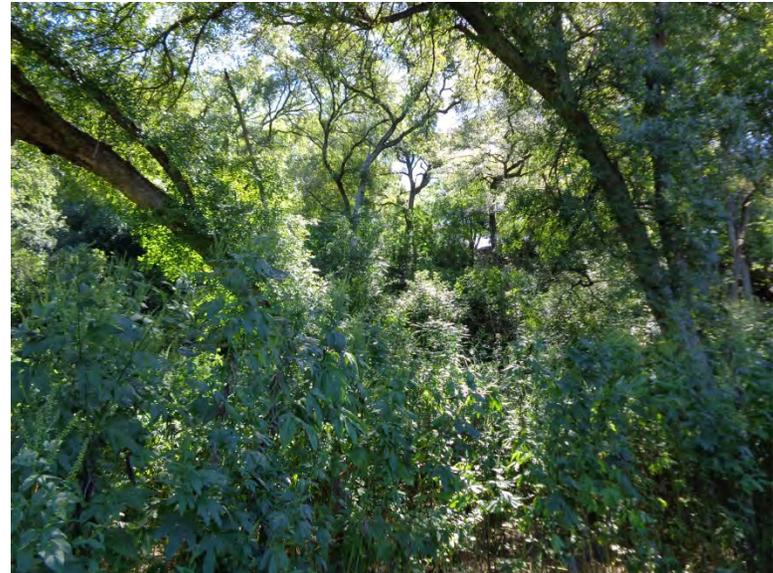
**Photopoint: 67**      **Direction: N**

Cedar elm overstory with hackberry, Japanese privet, Chinaberry, and ragweed also present.

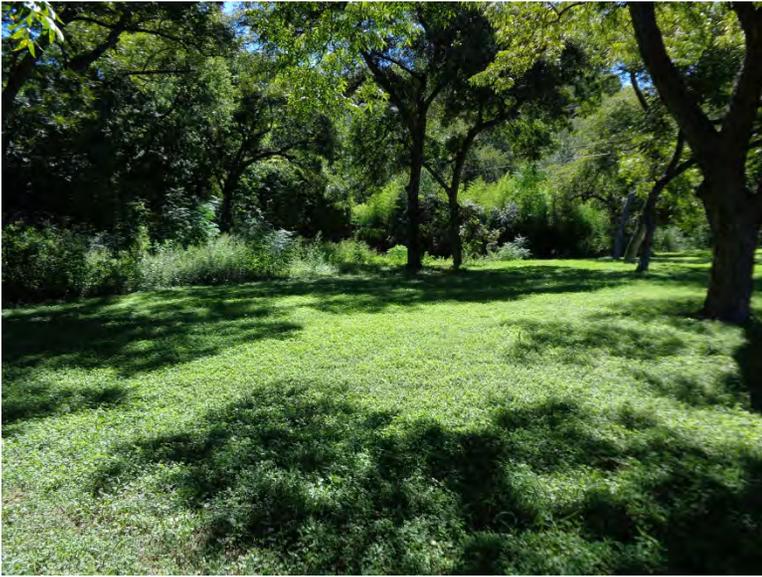
**Photopoint: 68**      **Direction: E**

Pecan grove with mown understory and horseherb herbaceous layer. Beyond the mown area is a wall of bamboo, Chinaberry, and privet.

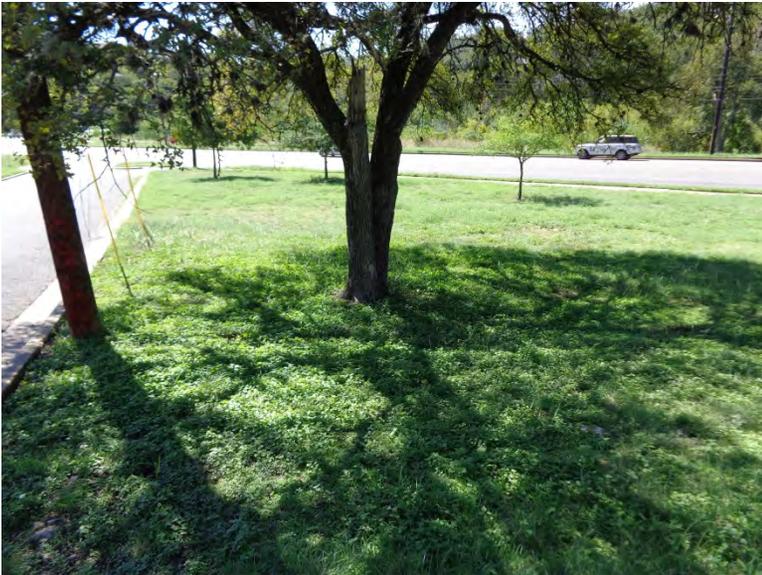
**Photopoint: 69**      **Direction: SW**

Open areas near San Gabriel and Lamar. An infestation of purple lantana is in the woods to the north of this location.
